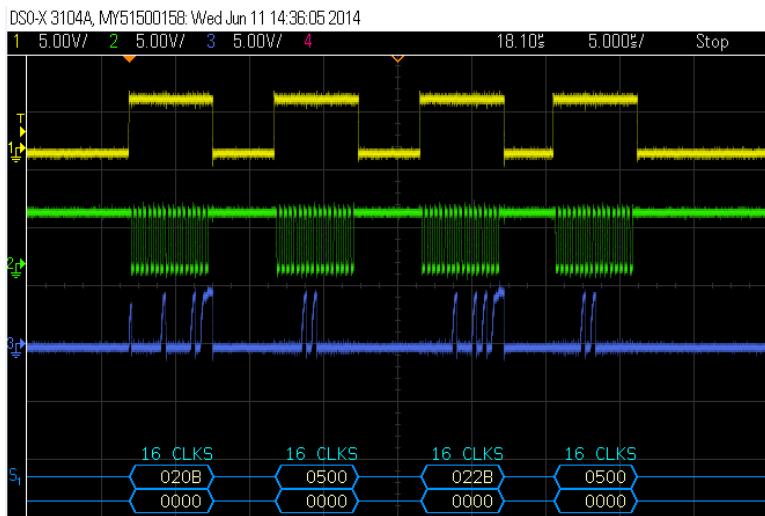
Correct zeroing of current.

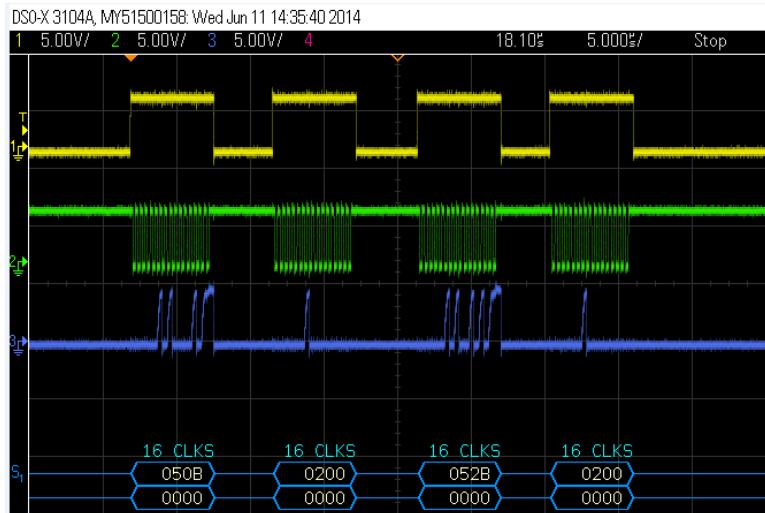
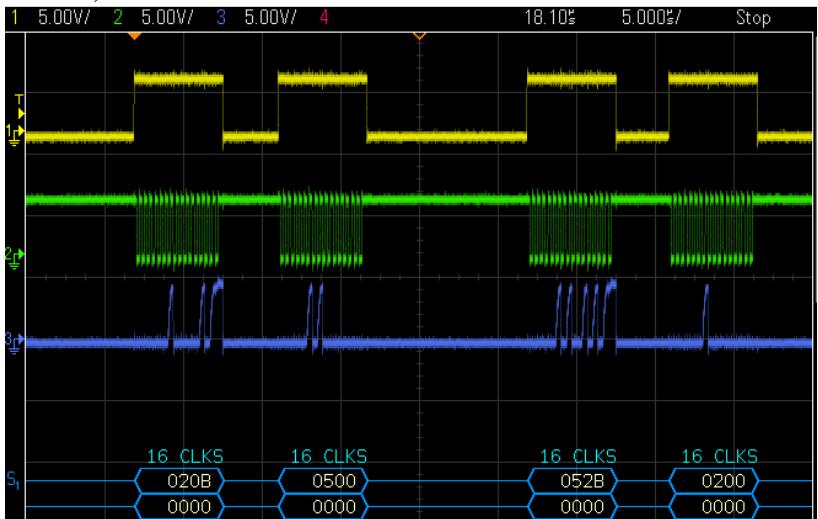
Bad display of zeroing current.

First case first nibble of 1st byte gets swapped with 1st nibble of 2nd byte, both sets.

Second case similar but in second set.

Thursday thought had fixed it by adding clear tx & rx buffer at end of txmt routine.

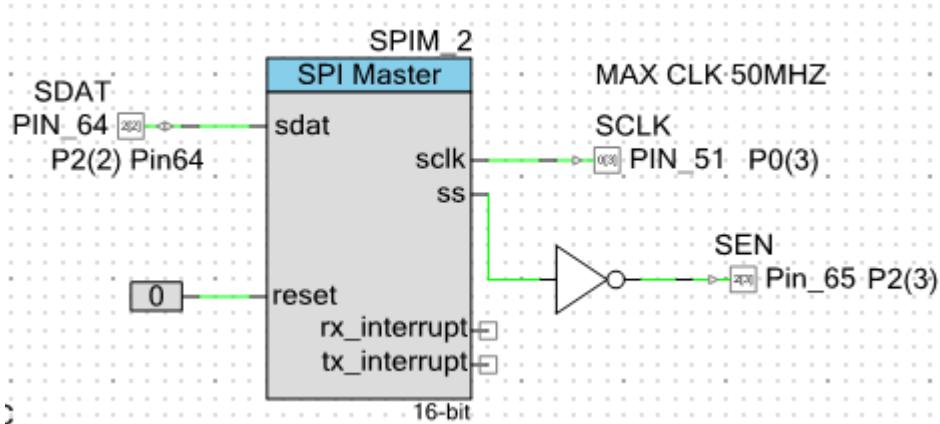
Top trace is SEN, followed by SCLK, then SDAT.

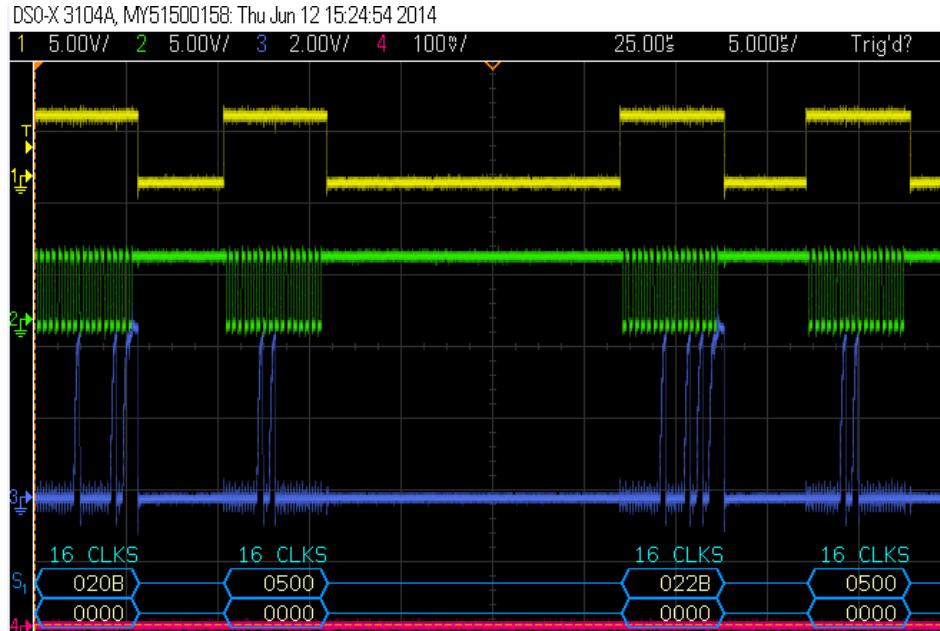
Below correct.

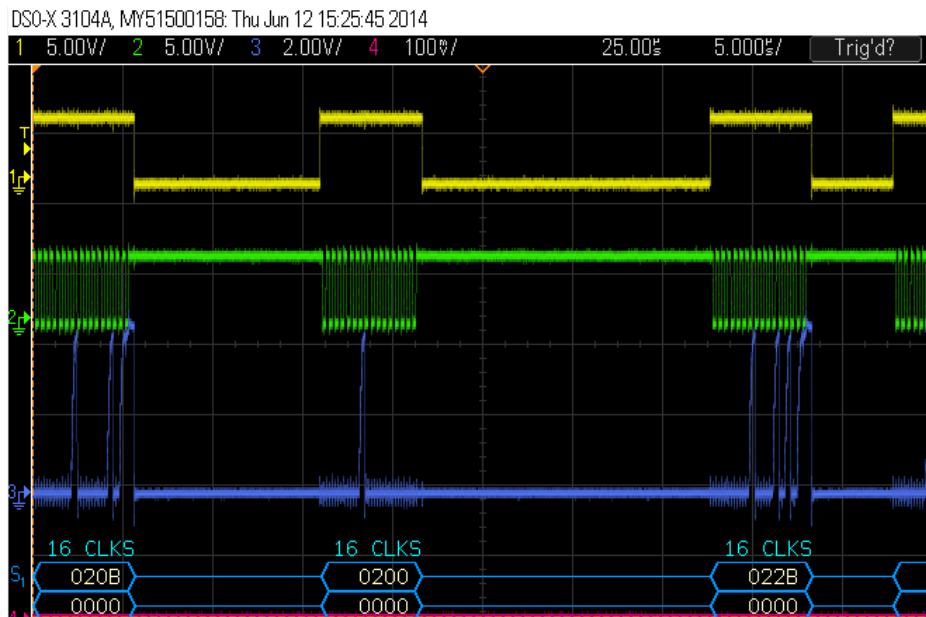
This time the command, instead of 020B, 0500, get 020B, 0200.

No longer swapping, but not updating a nibble.

Then incorrect.

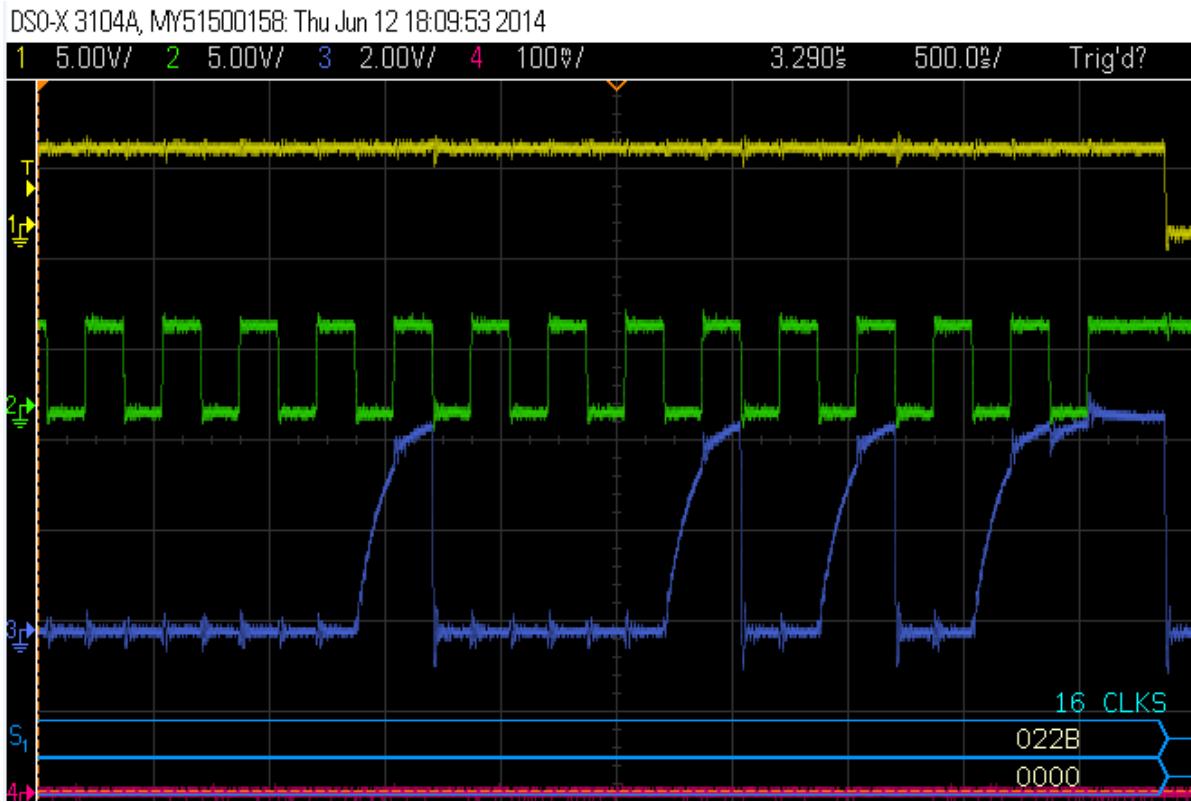
As far as rise time of SDAT

With slave connected:

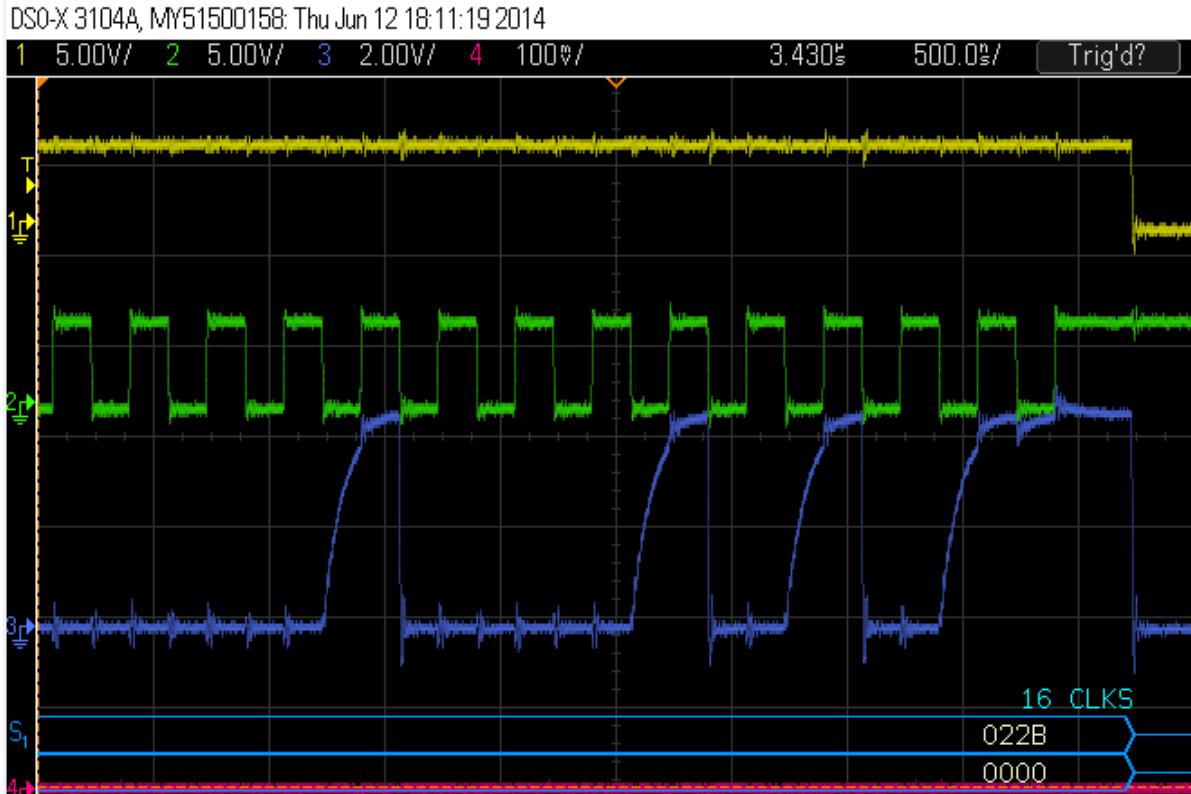
With slave not connected, nothing else on SDAT except a 10k pullup. As below:

The slave datasheet says input currents of 15uA, and when outputs, up to 5mA.
