# CY3271 Pig Tail Thermistor Connector Incorrect

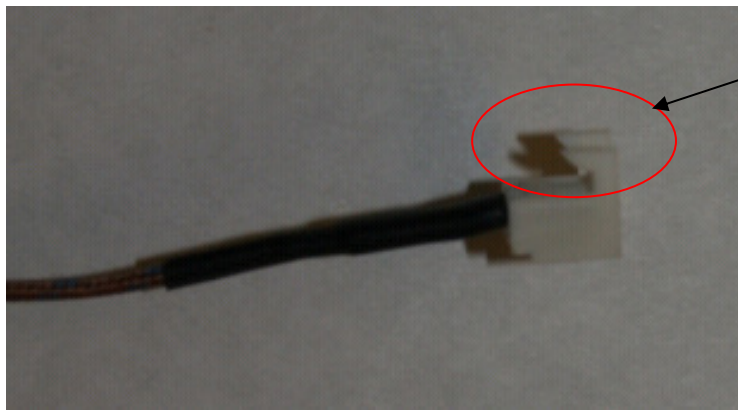
Question: The pig tail connector on the Thermistor does not fit the mating connector on the board.

Remove two prongs with scissors

Response: Remove prongs off thermistor connector with scissors. As polarization is not required for the thermistor, this will not affect the operation of the CY3271 RF Node board. Please refer the attached picture for reference.
